Derailment of Coal Train EG37

Connors Range

1 July 2001

October 2001

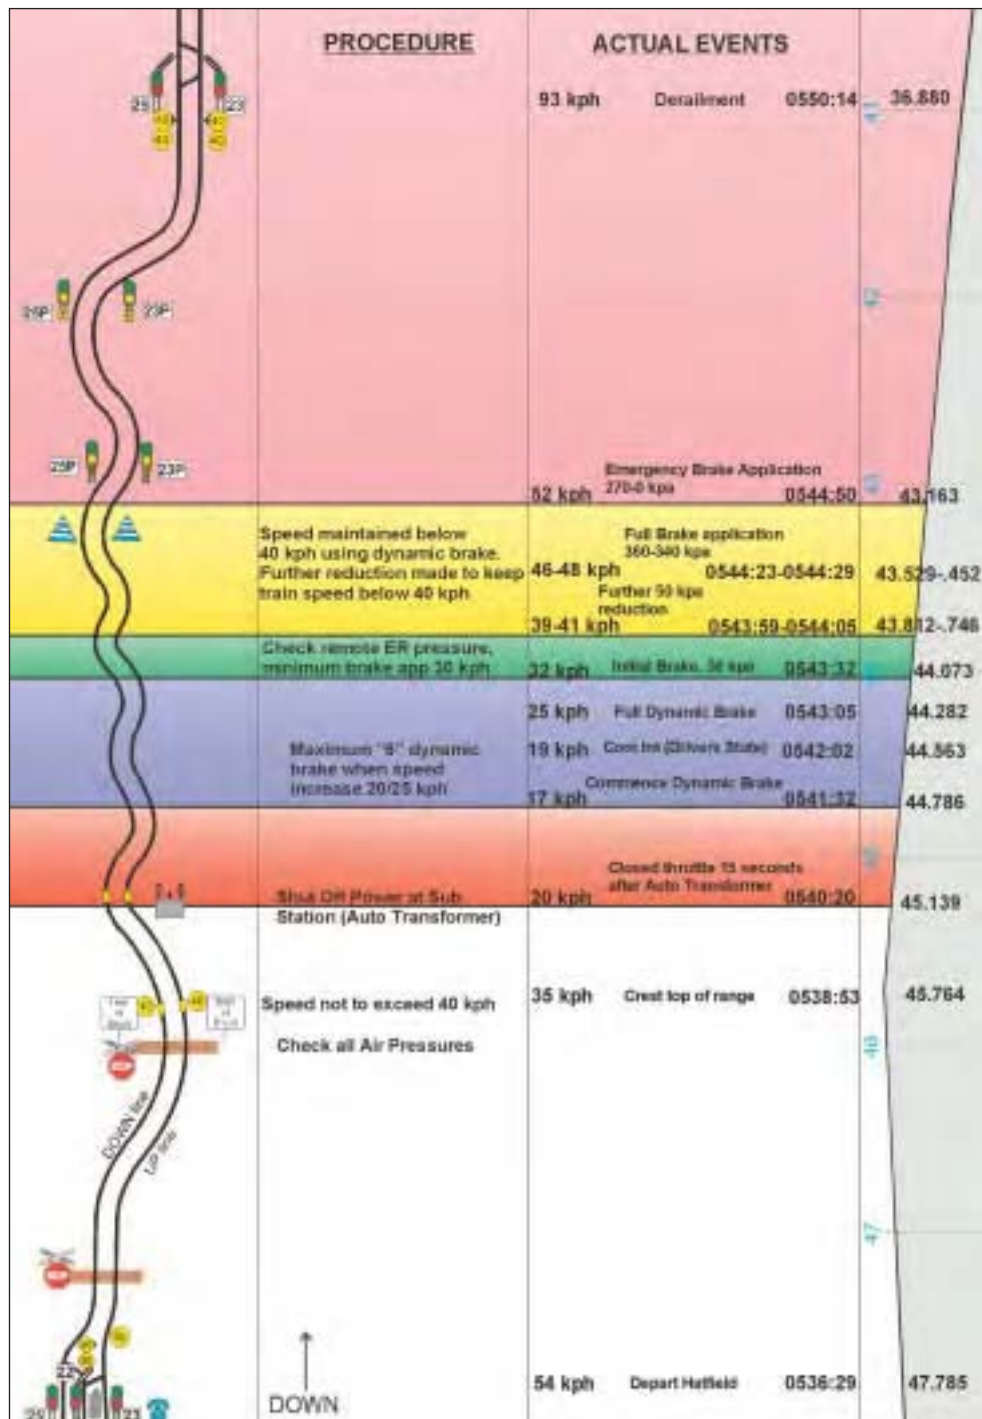
Figure 4:
Comparative presentation of written procedure for handling trains down Connors Range and actual events relating to EG37

At the Point of Balance⁹, EG37 had slowed to its lowest speed of 17 km/h. At that time, the Driver commenced to engage Dynamic Brake. Over a period of about one and half minutes, the Driver continued to increase Dynamic Brake. The train commenced to accelerate slowly during that time. Before Dynamic Brake had been fully applied, the Driver reported that the Locotrol display indicated that a communications interruption (Com Int) had occurred (see fig. 2). The red Com Int warning light was illuminated and the Dynamic Brake indication was flashing at Dynamic Brake level '8'.

Note: A diagram of the prescribed procedures for handling trains down the Connors Range compared with the actual events described above, can be viewed at figure 4.

Route-specific instructions on how to handle trains whilst descending the Connors Range are also provided to Drivers. Those instructions have been referred to for comparative analysis of the Driver's actions and are contained in figure 4. Those instructions do not refer specifically to handling a train while in a state of Com Int on the range. However, amended procedures that were introduced following the derailment, provide directions to Drivers about what actions to take if a Com Int is experienced.

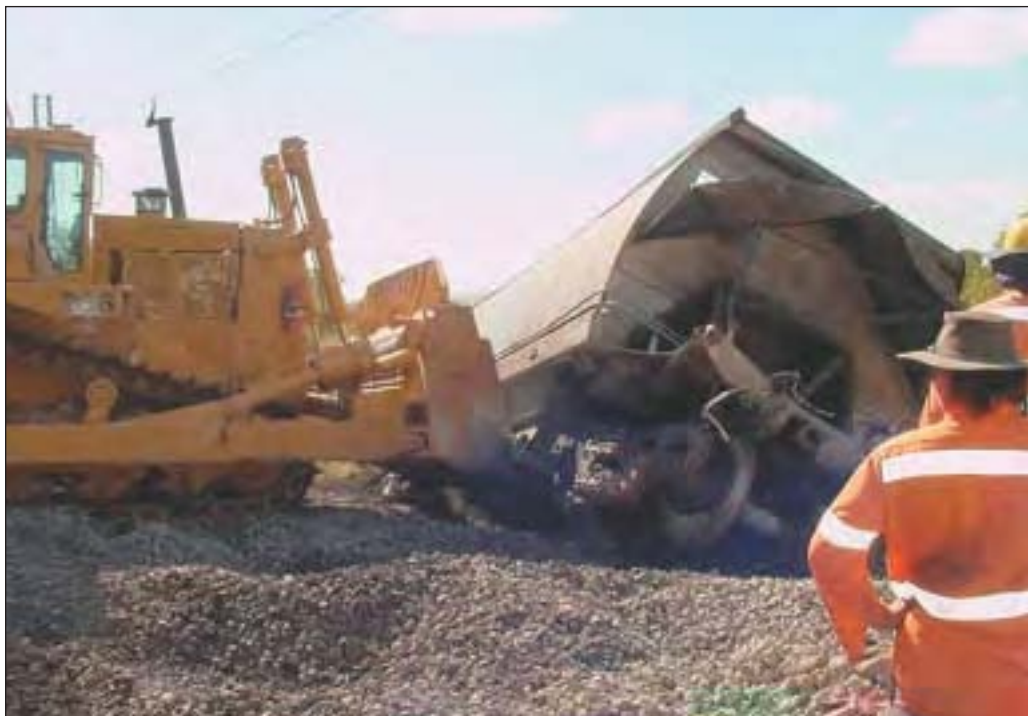
Figure 10:
Recovery operation in progress

The recovery operation continued around the clock to remove damaged rollingstock from the track and to restore damaged rail, the overhead power supply, and related infrastructure (see fig. 10). The track was re-opened for operation at 1910 hours on Thursday 5 July, with train services operating in accordance with a modified procedure (Refer to *Safety Action Taken* in this report).

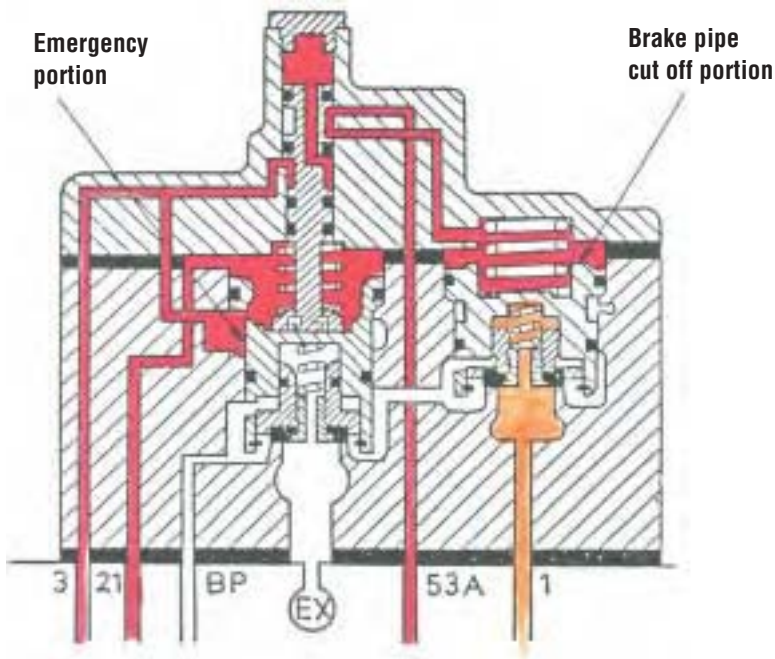
Figure 12:
Schematic of Brake Pipe Control Valve during Remote Feed Valve 'cut out'

When the Feed Valve 'cut out' command is given, Feed Valve 'cut out' is achieved by delivering Main Reservoir²⁰ air pressure into the '53A' pipe, which connects to the cut-off portion of the Brake Pipe Control Valve (see fig. 12). This action results in the Train Brake Pipe being sealed at the ELRC and prevents any further Train Brake releases or applications by the ELRC. The train then becomes a 'head-end-only'²¹ train, but is still under the control of the Driver. All Train Brake applications and releases are then propagated only from the front of the train and not also from the ELRC.

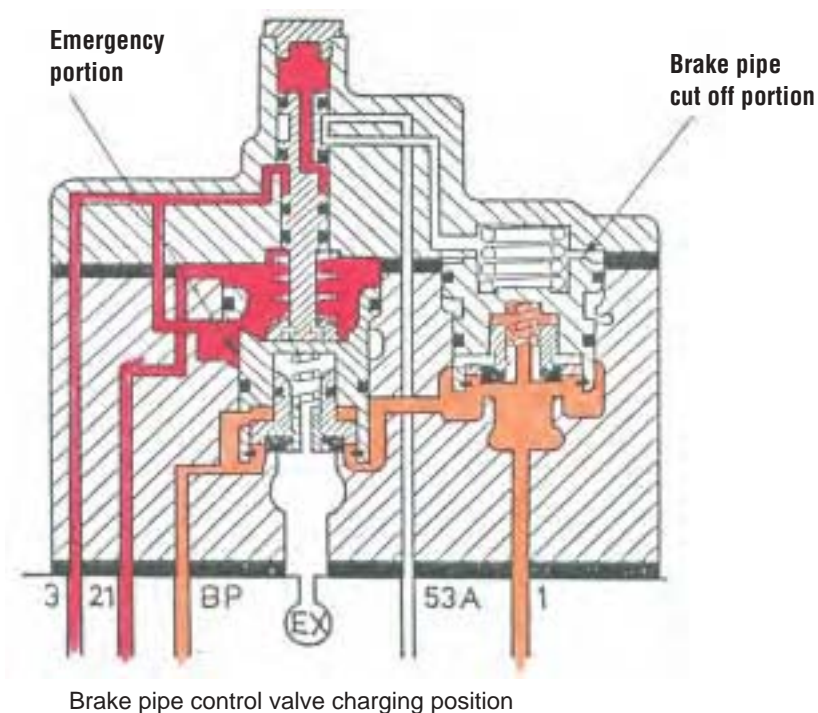
Figure 13:
Schematic of Brake Pipe Control Valve with Remote Feed Valve 'cut in'

When Locotrol radio communications are operating normally via Data Radios as previously described, and with the Feed Valve 'cut in', the Brake Pipe Control Valve is open and allows air to flow freely between the Brake Pipe and the Relay Valve in the ELRC (see fig. 13). The Relay Valve is controlled by the Driver's actions in the lead locomotive. Train Brake applications and releases made by the Driver in the lead Locomotive, are mirrored in the ELRC. If the Driver commands Feed Valve out (for example, as part of a normal test procedure) or the Remote Feed Valve in the ELRC cuts itself out for some reason, the Driver would receive a Feed Valve OUT indication on his Locotrol console. During a state of Com Int, however, a Driver does not receive real-time information about the status of the Remote Feed Valve.

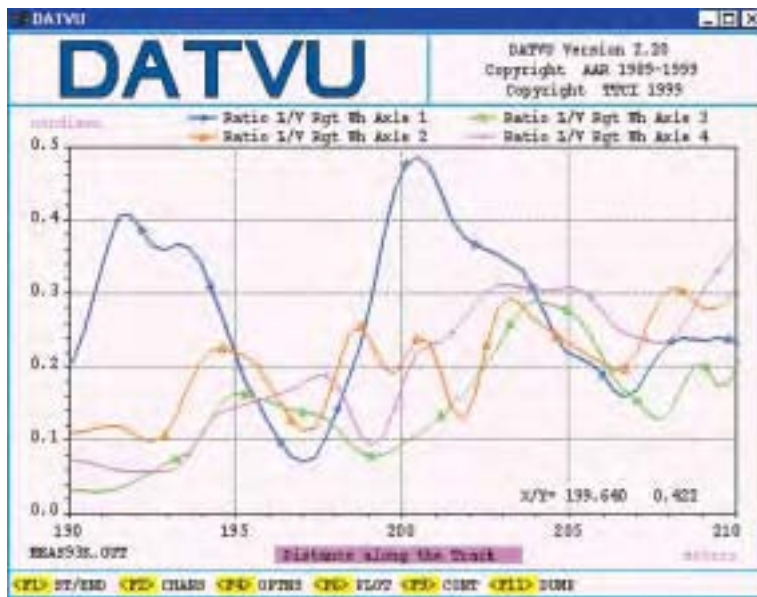
Figure 15:
Results of L/V ratios in area of derailment

The lateral to vertical force ratio (L/V)²⁹ for the leading wheels on the high rail³⁰ reached a maximum (sustained for 2 m) of only 0.42, indicating that it was unlikely that the derailment was a result of flange climb (see fig. 15).

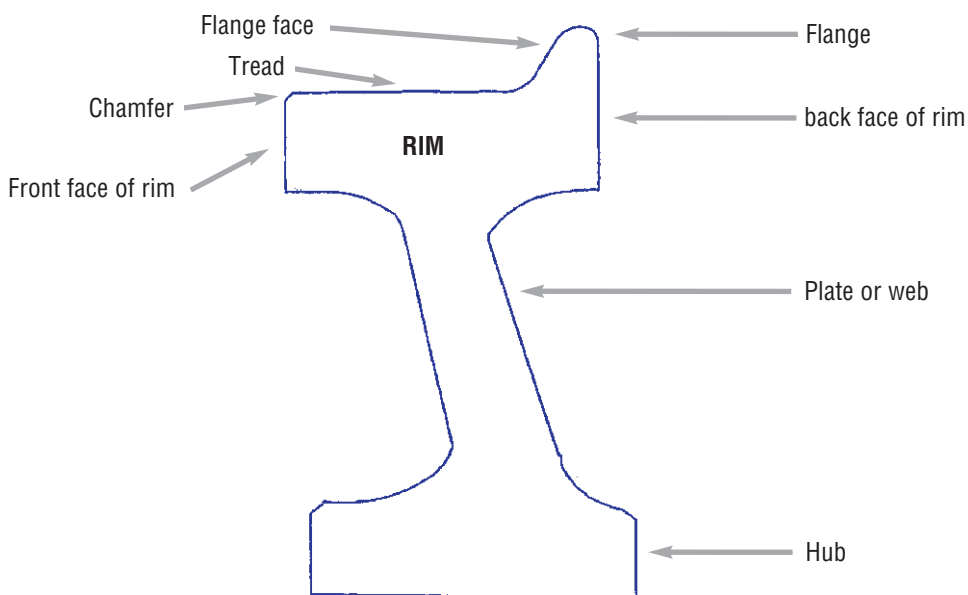
Figure 18:
Schematic cross-sectional diagram showing the parts of a typical wheel

Wagon wheels on both VHS-type and VSA-type wagons in the general wagon fleet (not part of EG37) were also inspected at Jilalan Depot for the purpose of comparison with the wagons of EG37. Most of those wagon wheels showed signs of previous severe heating. Only a very small number of recently fitted wheels on those wagons did not also exhibit signs of previous severe wheel heating. Most wheels on wagons in the Depot showed signs of both wheel rim front-face and complete and near-complete wheel-web heating (see fig. 18 for schematic diagram of the parts of a typical wheel).

Wheel tread heating on wagons hauled from the derailment site was not evident. Any signs of heating on the wheel treads of the wagons on the front portion of EG37 were most likely removed by the action of the wheel tread against the rail as the loaded wagons were moved. The rear wagons at Hatfield, however, had only travelled a few kilometres, therefore, residual signs of heat stress on the wheel treads were more likely to be seen on those wagons though none was found. Some of those wagons, as for the general inspection of wagons that were not part of EG37, showed signs of severe wheel rim front-face and wheel-web heating.
